# Flash Flood Guidance Gazette

Flash Flood Guidance (FFG) Gazette, a bi-annual newsletter bringing users of FFG products all the latest news – operational information, technical advances, case studies and education for the flash flood community.

## Flash Floods in Croatia – A Case Study of 14th October 2015

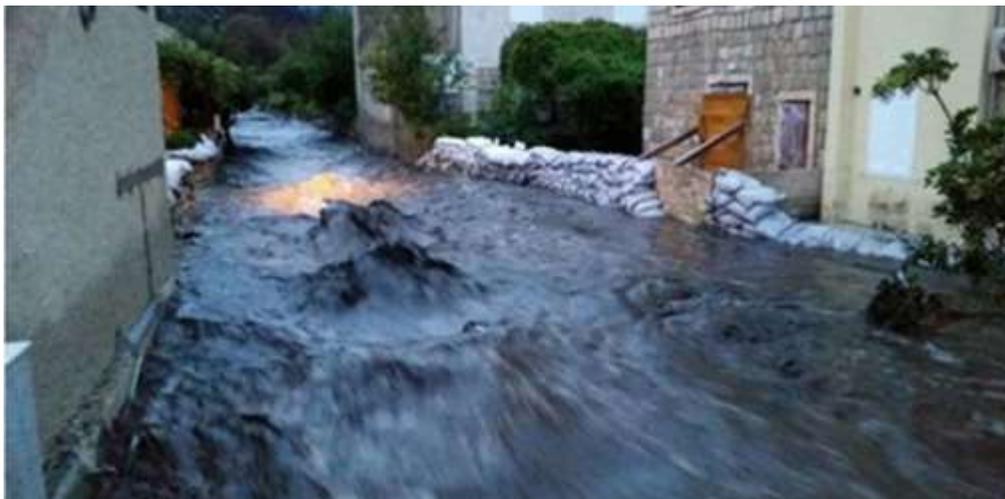
**Figure 3. Flash floods along the coastal Croatia on October 14th, 2015**

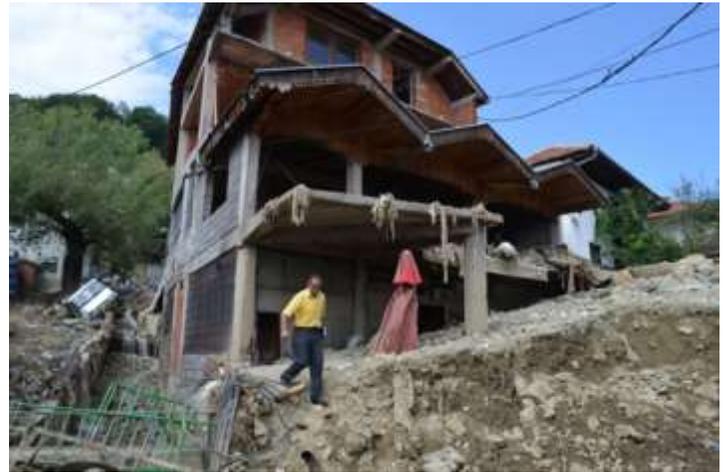
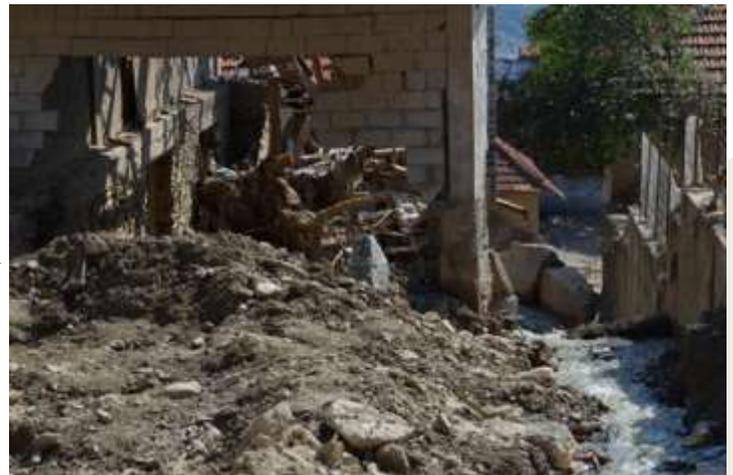
Figure 1. Damaged houses in Shipkovica

The village of Shipkovica is located on the slope of the Sar Planina mountain in northern Macedonia. According to witnesses, the rain started around 15:00 local time (13:00 UTC), as a normal or common rainfall. However, it progressed into precipitation with strong intensity for approximately an hour. At 17:30 (15:30 UTC), water started to flow through the gully in the middle of the village. After only 10-15 minutes, large amount of dirt, sand and stones were being carried by the water, and were crashing between and through the houses. The flood wave passed through the village. The flow in the gully subsided at 18:00 (16:00 UTC), leaving much devastation as shown in the figures.

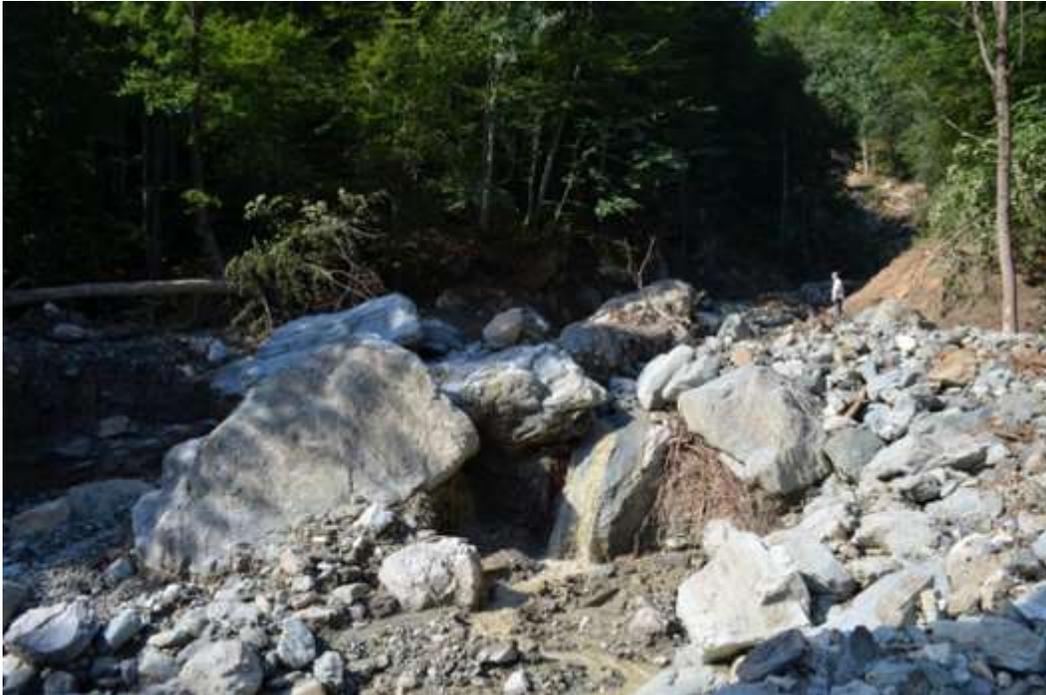
After this event, I reviewed the event through the SEEFFG System. The satellite observations of precipitation (gridded GHE) indicated heavier precipitation of up to 40 mm/6-hr in the central to north-central part of Macedonia at 15:00 UTC. Heavy rain was also indicated to the southwest and into Greece. The heavier precipitation was to the south of the Sar Planina mountain. Soil moisture conditions as indicated by the FFG system were fairly low throughout Macedonia prior to the event (12:00 UTC) but changed quickly to high saturation for some basins by 18:00 UTC. The FFG values were low for several basins to the south of the Sar Planina mountain (for example, as low as 25 mm/3-hr), and on the order of 25-40 mm/3-hr for the region of Shipkovica. The forecast of precipitation within the System indicated numerous heavier rainfall throughout Macedonia, with highest rates of 40-50 mm/3-hr, but located further south of the Shipkovica region, and 20 mm/3-hr in the region. The flash flood basins in the north of Macedonia showed very low FFG

values (order of 10-15 mm/3-hr) at the end of the event at 18:00 UTC. Knowledge of local conditions and the location of heavy precipitation (both observed and forecast) were critical in assessing the situation for this event.

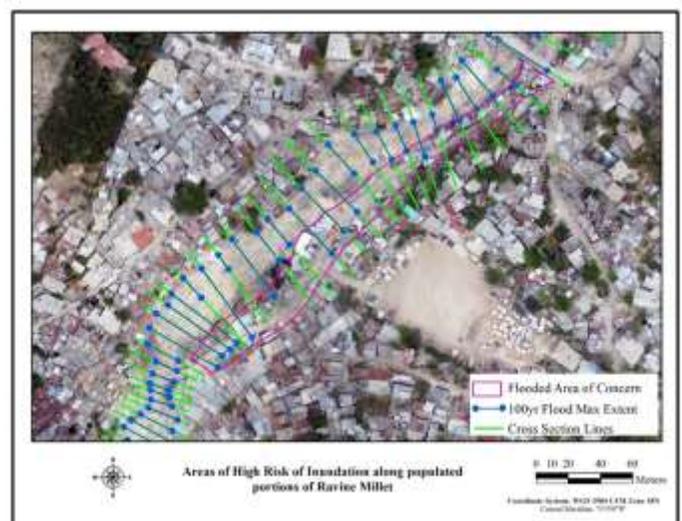
Figure 2. Areas of High Risk of Inundation along populated portions of Ravine Millet
